Clinical Image

The Utility of Dual-Energy Computed Tomography in the Diagnosis of Pulmonary Thromboembolism Caused by Post-Vertebroplasty Cement: A Case Report[☆]

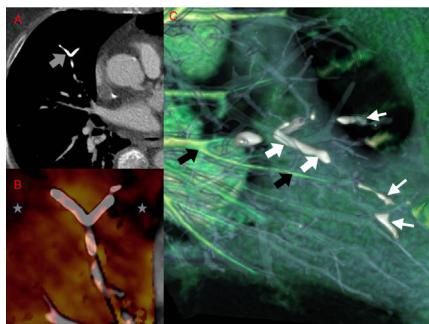
Fig. 1. Dual-energy computed tomography after the administration of intravenous iodinated contrast medium. (A) Axial image revealing a high-density branched linear image in a subsegmentary artery in the medial segment of the middle lobe (gray arrow) suggestive of cement embolism. (B) Iodine perfusion map revealing areas of hypoperfusion (gray stars) distal to the dense linear lesion described previously. (C) Vascular map showing vessels containing iodine colored green (black arrows) and filling defects attributable to the cement in white (thick white arrows). Note how this kind of reconstruction can be used to identify a greater number of small caliber vessel defects (thin white arrows).

The CT pulmonary angiogram showed high-density images in the subsegmentary pulmonary branches (Fig. 1A) and in the azygos vein (adjacent to the treated vertebrae). Perfusion reconstructions with iodine and vascular mapping were used to differentiate areas of hypoperfusion (Fig. 1B) and cement embolism from endovascular iodine (Fig. 1C).
