Clinical Image

## Pulmonary Embolism Caused by a Migrated Biochip: An Alert for the Future

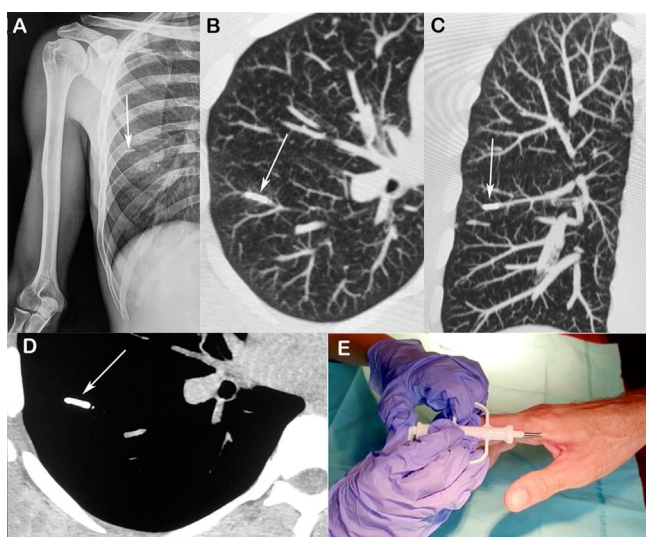
**Fig. 1.** (A) Anteroposterior radiograph of the right humerus showing a small, dense linear projection in the right hemithorax (arrow). (B and C) Axial and coronal reconstructed images depicting the device lodged in a vascular branch of the right lower lobe of the lung (arrows). (D) Axial CT image (obtained with the mediastinal window setting) showing the small metallic device (arrow). (E) The biochip being implanted in the patient's hand.

A 34-year-old man was referred to our department after a biochip implanted in his right hand stopped working. As he could not feel the device, the manufacturer instructed him to undergo simple radiography of the right upper limb. Radiographs revealed a small metallic foreign body in the right hemithorax. Chest CT showed the biochip lodged in a vascular branch of the right lower lobe of the lung (Fig. 1). The patient was diagnosed with pulmonary

Human biochips are small devices encased in glass, measuring approximately  $12 \times 1-2$  mm, covered by a material that prevents oxidation and, consequently, inflammation. The chip is usually implanted subdermally in the hand, injected under the skin using a hypodermic syringe, between the thumb and forefinger, an area with few nerve endings and blood vessels, considered practical and safe for this purpose. Although the literature on the subject is scarce, the probable mechanism of the embolism observed in our patient was the chip's inadvertent intravenous implantation. One possible way to avoid this complication would be the implantation being done by health professionals, such as doctors and nurses, or guided by ultrasonography.
