Clinical Image

Fracture of Tracheostomy Cannula and Removal Using Flexible Bronchoscopy

Interventional Pulmonology Unit, University Clinical Hospital of Valladolid, Spain

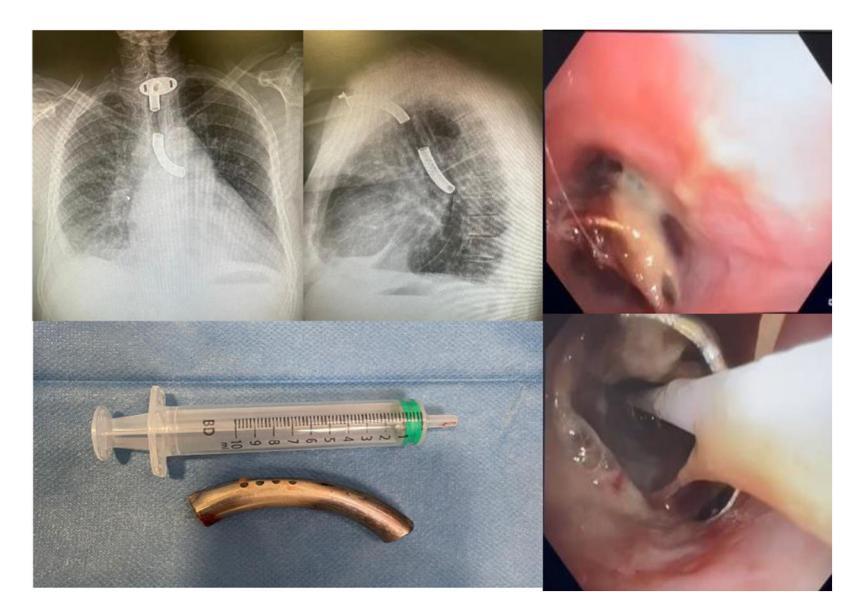
Fig. 1. Foreign body in the left main bronchus. Fogarty balloon extraction.

We describe the case of a 66-year-old male who underwent laryngectomy for laryngeal neoplasia in 2004 and has been using a silver cannula since then. He was brought to the Emergency Department due to sudden dyspnea and hemoptysis. An emergency X-ray revealed that the silver cannula was broken, with the distal cylindrical part separated from the proximal end. An urgent bronchoscopy was performed, revealing the cylindrical part lodged in the trachea and extending into the left main bronchus. It was decided to remove it using flexible bronchoscopy under sedation by inserting a dilation balloon distal to the detached end of the cannula and withdrawing it in one piece with the bronchoscope (Fig. 1). Among the causes of tracheostomy fractures are from defects in the material and design of the cannula to local chemical reactions caused by the patient's secretions that degrade the material.¹ It is generally accepted that in cases of prolonged tracheostomies, the advantage of silver cannulas lies in their greater durability, lower infection rates due to sterilization capabilities, and biocompatibility.²
